# NS32332 CPU REVISION C

January 21, 1987

This is the new user information sheet for the NS32332 Rev C.

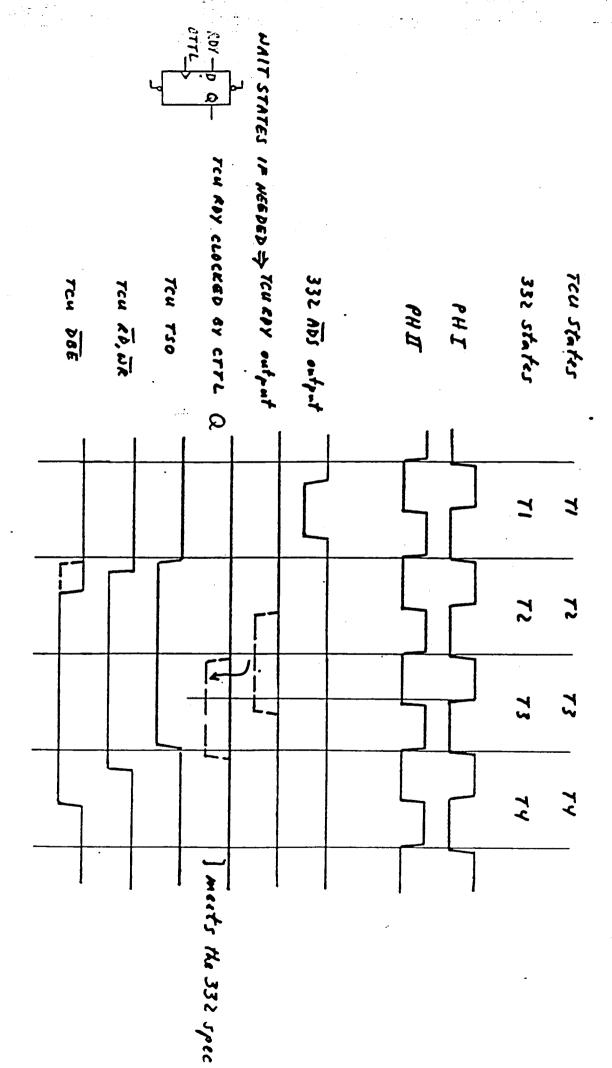
Figure 1

In a configuration without an MMU, TCU and CPU both run four clock cycle bus (figure 1). The RDY signal is the only incompatible signal between the CPU and the TCU and therefore the RDY output of the TCU should not be directly connected to the RDY input of the NS32332. The NS32332 samples its RDY the middle of T3 while the NS32201 asserts its RDY output shortly after the middle of T2 and removes it the middle of T3, thus the NS32332 RDY input hold time (tRDYh) is not met. To meet tRDYh, the RDY output NS32201 should be clocked by the rising edge of the CTTL using a D type flip-flop (74AS74) and then taken to the NS32332. should be noted that the NS32332 outputs the data in a write cycle in T3 unless DT/SDONE pin is sampled low on the rising edge of the reset in which case the data is output during T2. The DT/SDONE pin is implemented as of revision B of NS32332.

332, TCU timing diagram, NO wait state, No MMU

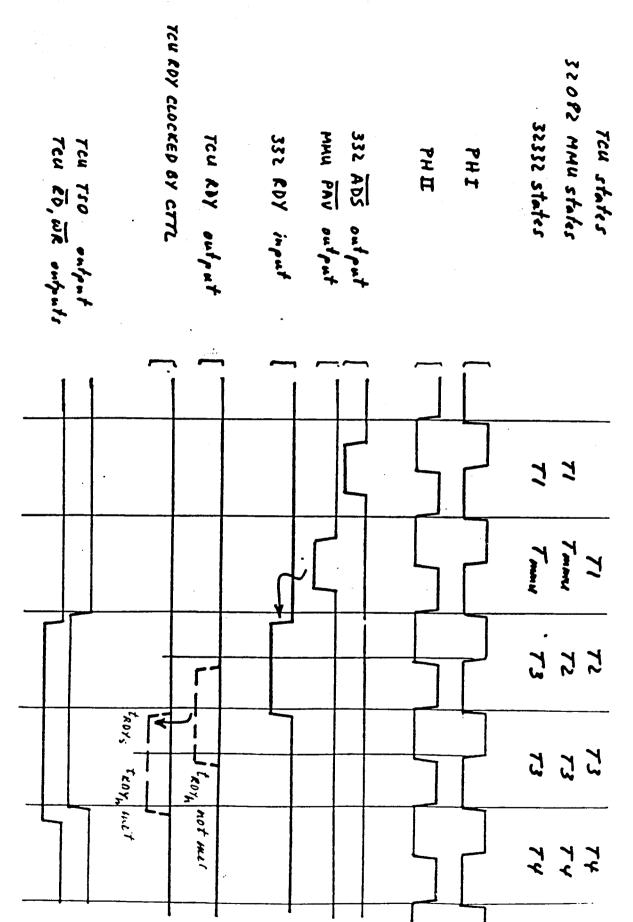
Figure 2

The first option is extending the NS32332 bus cycle to five clocks by adding a blind wait state that bypasses the NS32201 (figure 2). This configuration generally requires the minimum hardware modification for a 320xx based design to run the NS32332. Here the NS32201 output signals can be used to interface the NS32332 and the NS32082 to the memory or I/O. Additional wait states can be inserted by clocking the RDY output of the TCU.

similar to timing diagram of 332 adapter to 0832000

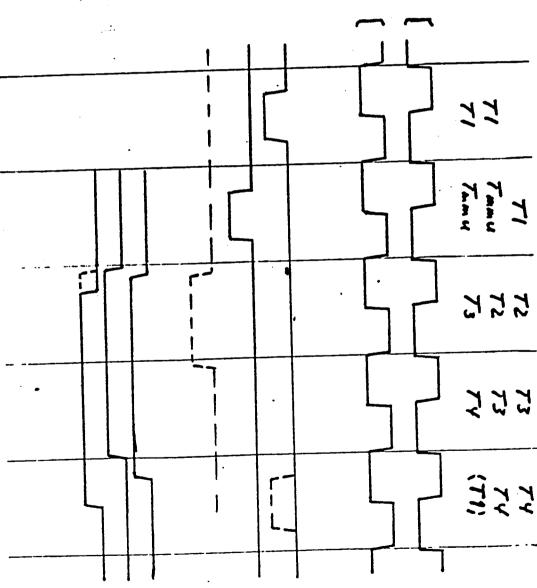
Figure 3

The second option is to have the NS32332 run a four clock cycle bus (figure 3). In this configuration the NS32201 output signals can not be used to interface the NS32332 to memory or I/O; they can only be used to interface the NS32082 to the memory. In this configuration a revision N of the NS32082 should be used.
